# Testing of temporary face support systems under rockfall conditions

J.L. HUMAN\* and N. FERNANDES†

\*SRK Consulting, Johannesburg

†Impala Platinum Limited

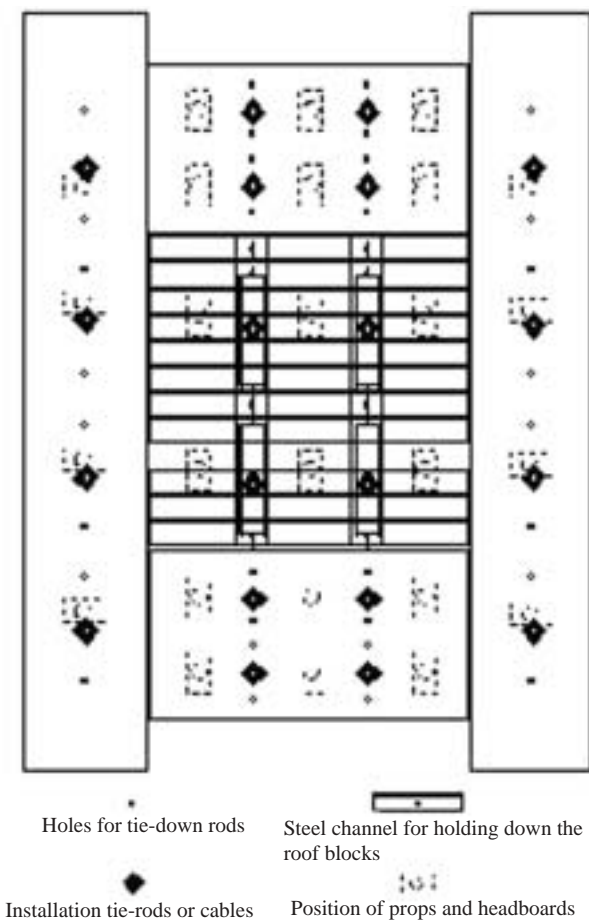
Figure 2. Plan view of the testing facility

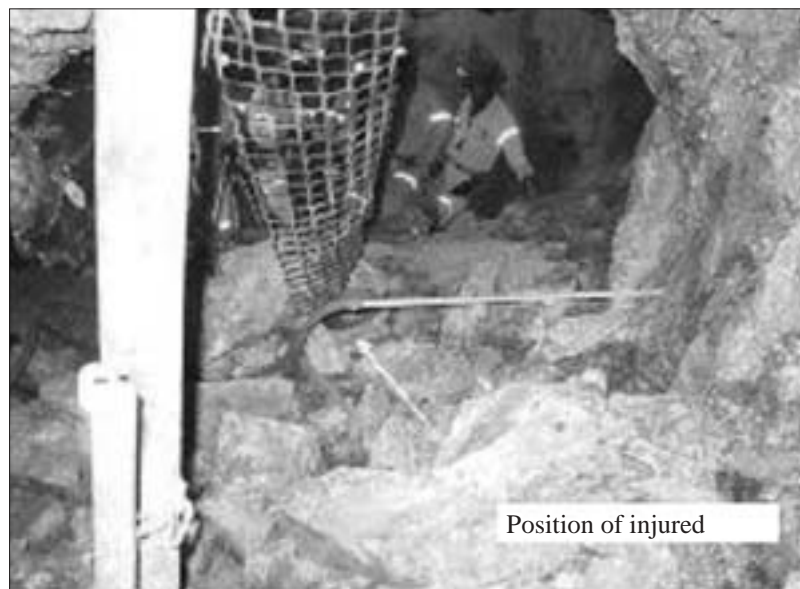
Figure 5. Scene of the fall of ground accident where the narrow safety strapping minimized the extent of the injuries to a stope worker

On 28 November 2003, the life of a rock drill operator was possibly saved due to the installation of strapping which was initially tested at the Savuka test facility. The fall of ground incident occurred at Impala Platinum Mine’s No. 14 Shaft, in the 16-101 4 south panel. The rock drill operator was busy drilling the stope face, when a fall of ground with an estimated mass of 350 kg occurred. The accident investigation done by the mine concluded that, although the safety strap had caused one of the temporary support units to dislodge, the strap had sufficiently reduced the momentum of the fall of ground, resulting in no serious injuries to the drill operator. Figure 5 shows the scene of the fall of ground incident and the position of the drill operator.

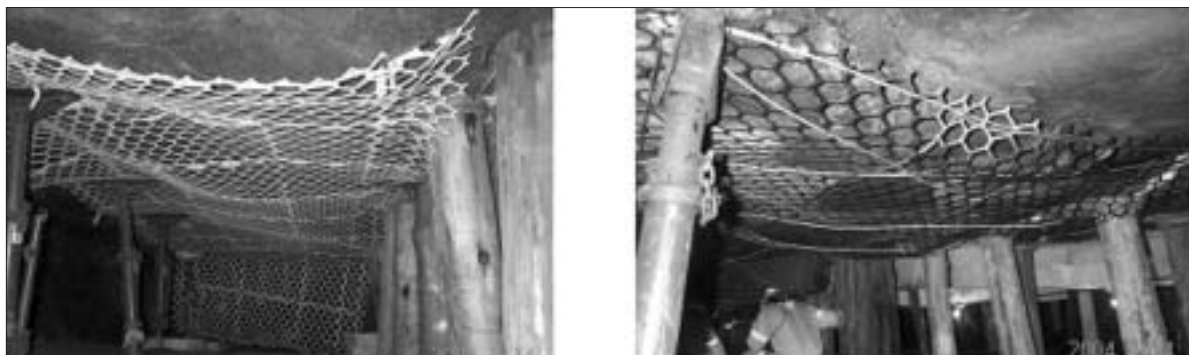
Figure 6. Photographs of the current types of safety net installations at Impala Platinum Mine

The 300 mm wide strap used when the fall of ground incident occurred has subsequently been replaced by larger safety netting, providing greater areal cover as shown in Figure 6. Two types of these larger safety nets are currently being used on the mine; both have reinforcing members, one woven cargo strapping and the other 6 mm cable.

Both of the safety net systems were installed and tested to hold 2 tons at the Savuka test facility under gravity-driven fall of ground conditions. The evaluation of these safety nets is still ongoing at Impala Platinum mine and further
